## LC-LJ TORANA BODY & FRONT END STRENGTHENING KIT INSTALLATION INSTRUCTIONS.

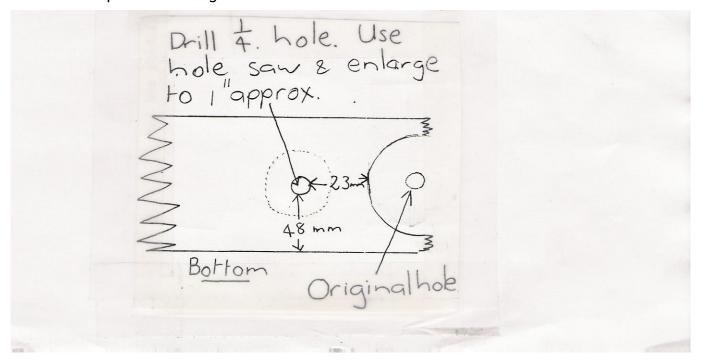
Remove front end from the car and wash it with a steam cleaner. The best job can only be done if the suspension is pulled apart. With a sanding buff clean paint and dirt from the bottom of the crossmember, around the edges and the hole in the middle. The steel plate is then located with an even gap around the edges, clamp tight and tack weld to hold. Remove clamps and tap ends down, clamp and tack prior to full welding around the outside. The pre cut hole in the plate is to allow welding. If your crossmember has been dented, heat plate and peen around hole until it meets prior to welding.

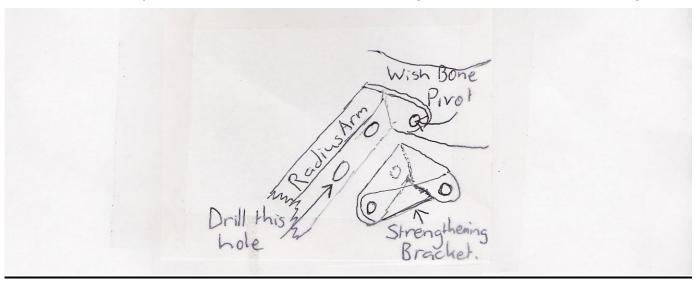
They will only fit one way. Bolt in with the control arm bolt. One hole already exists in the radius arm and one hole must be drilled.

See diagram for location to allow a straight drill through and to allow a socket in to tighten. Most Torana's crack badly in this area. These brackets are designed to make this area more rigid.

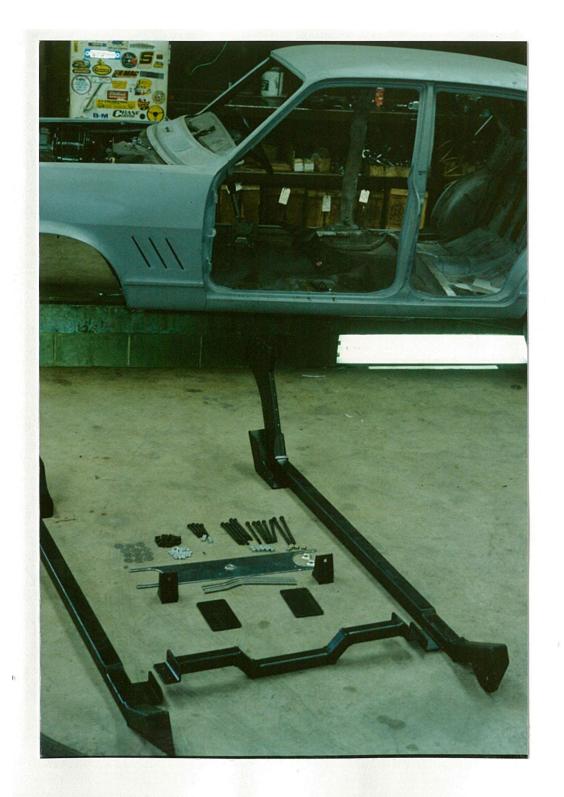
View of test vehicle in bare shell form as well as the components supplied in the complete kit.

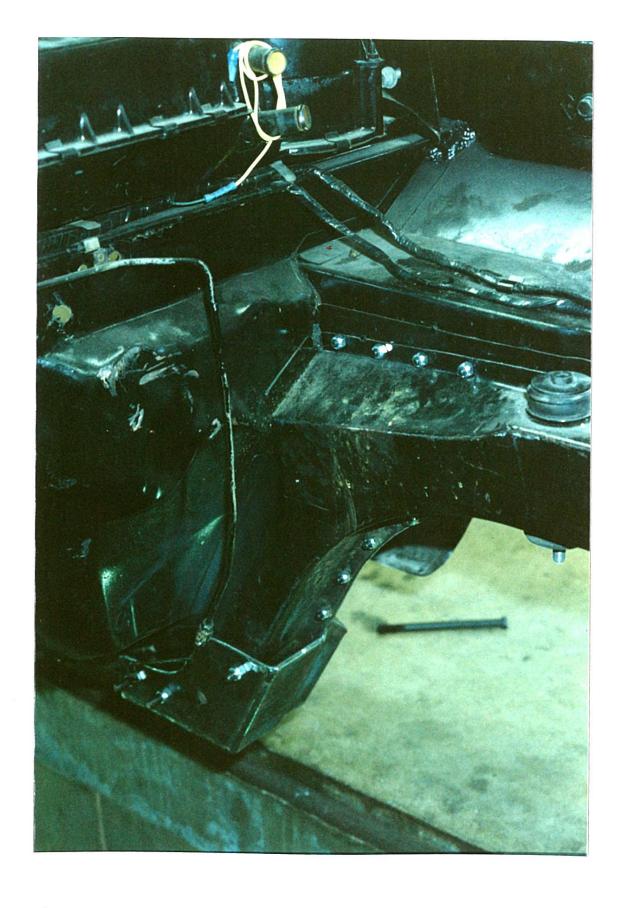
View of the front chassis rails, adjacent to the firewall, as seen from the centreline of the vehicle, showing attachment points indicated by the nylock nuts.

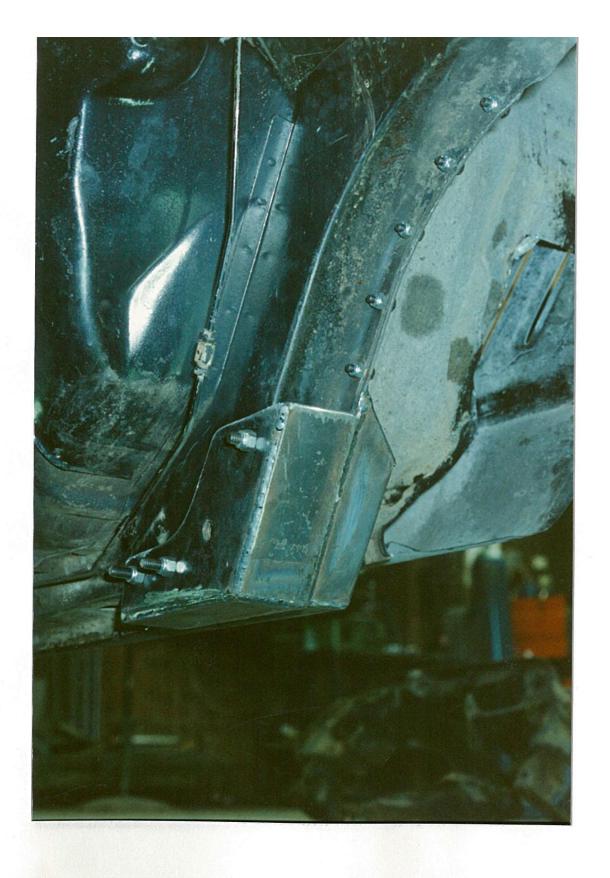
Lower section of the "U" shaped reinforcement section, attached to the original vehicle's chassis rail, showing through bolts adjacent to the flange of the original chassis rail. On the far side of the "U" shaped section, the R.H.S. is 7 commenced with a tapered section.

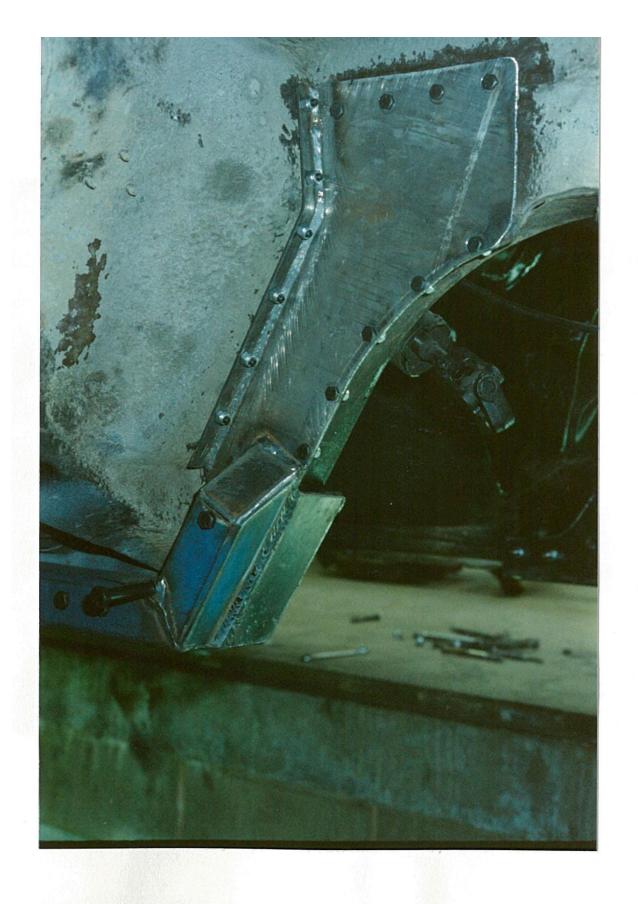
View from the outside of the chassis rail, i.e. from under the front mudguard, showing the reinforcement plate and commencement of the R.H.S., as well as the attachment points between the chassis rail and the vehicle floor.

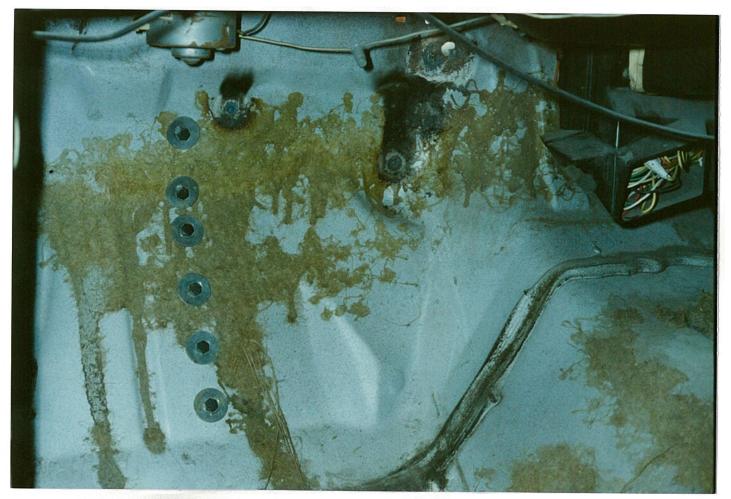
View of the interior of the vehicle floor, showing the attachment bolts of the reinforcement plate with mudguard washers to distribute the applied load.

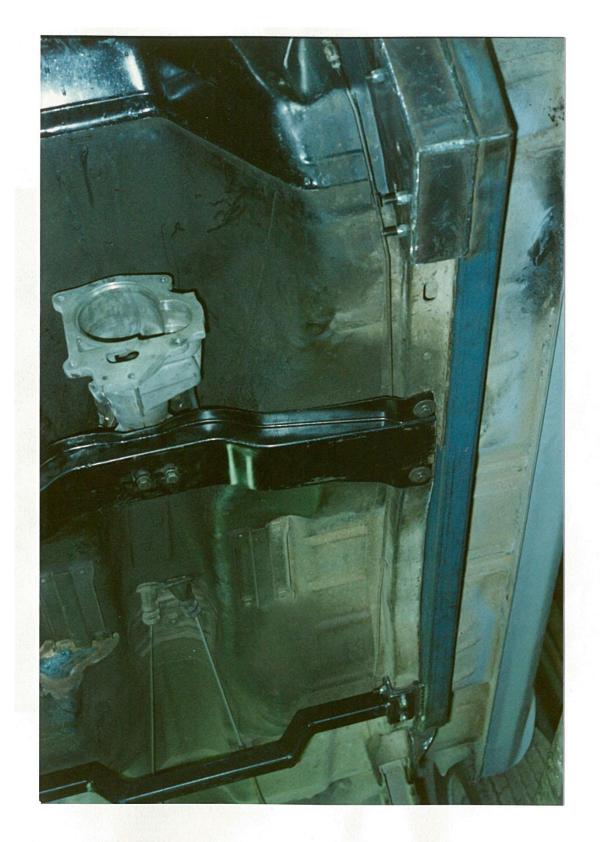
View of the underside of the vehicle, showing the R.H.S. reinforcement chassis rail placed adjacent to the original top hat section chassis rail. This also shows the main attachment points at the front and the rear of the vehicle, as well as additional attachment points near the rear suspension point where an additional crossmember is bolted on.

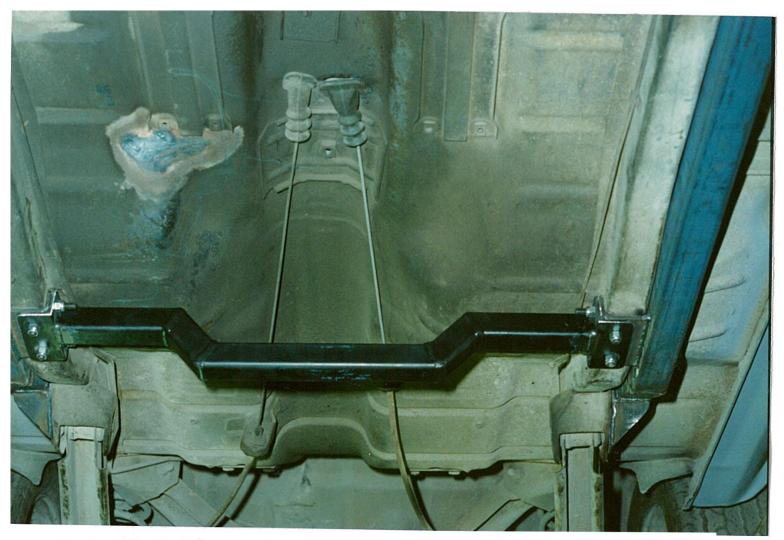
Detailed view of the additional rear crossmember which is stepped to allow room for the tailshaft, associated with suspension movement.

The two vertical bolts pass directly through the original top hat section chassis rail and provide additional attachment to the vehicle floor.

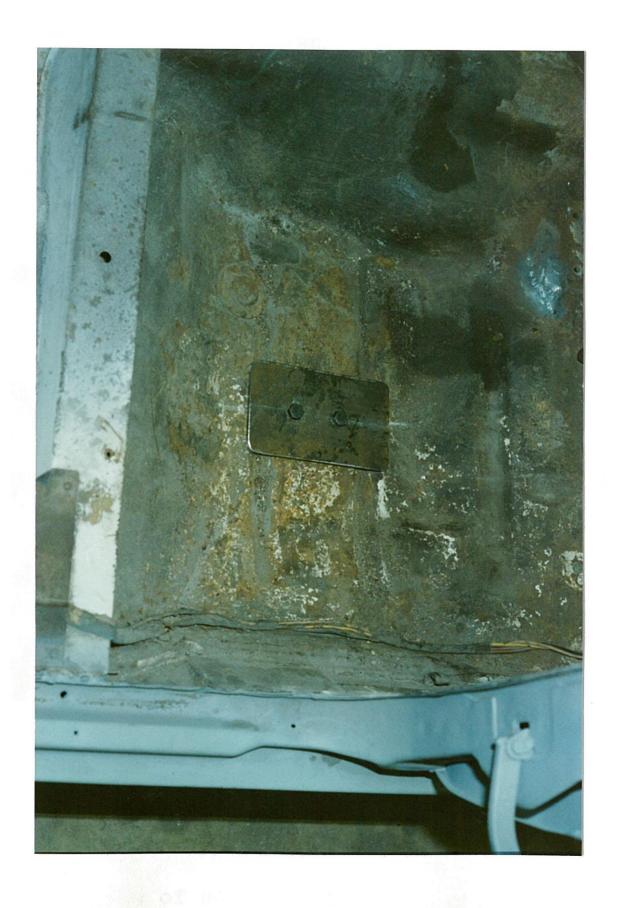
View of the floor under the rear passenger seat, where the spreader plate of the chassis and crossmember attachment point is located.

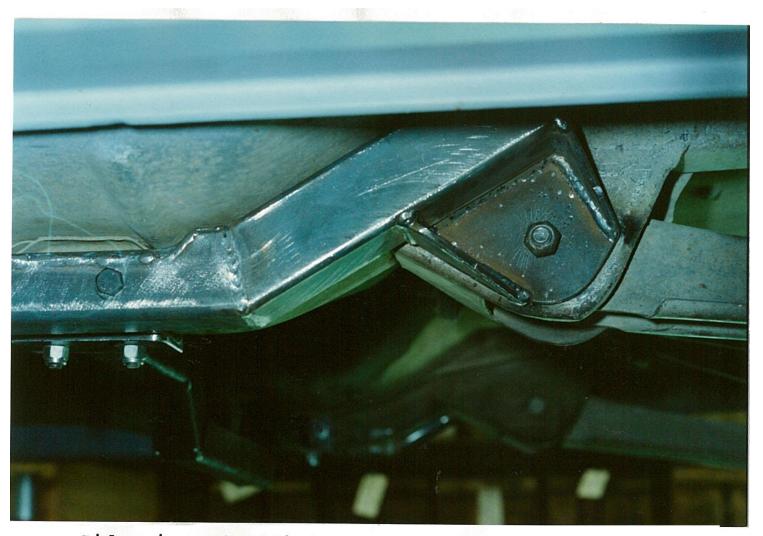
Side view of additional R.H.S. chassis rail, showing the rear crossmember attachment point and final attachment to the lower rear suspensions point.

A tapered washer is placed between this mounting flange and the side flange of the suspension point to prevent distortion when the bolt is tightened.

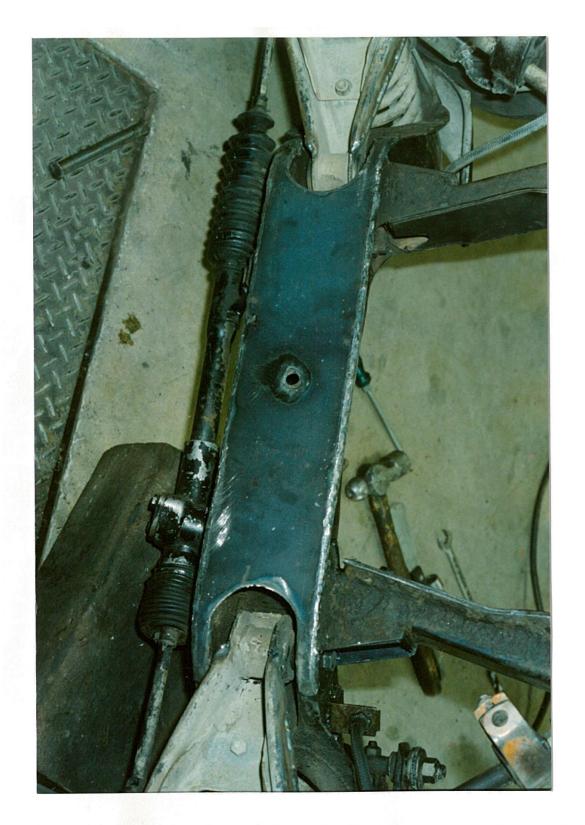
View of the underside of the crossmember showing the installation of the reinforcement plate and full perimeter welding. The original drain hole in the center of the crossmember has been retained.

As far as possible, the lower plate of the original crossmember should be straightened prior to attachment of this reinforcement plate.

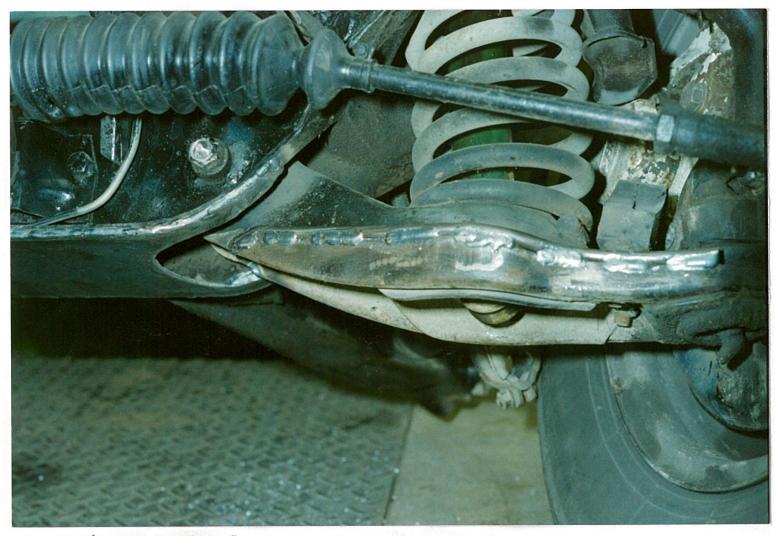
View of the lower suspension control arm, showing the reinforcement bar welded to the up-turned side of the flange.

A similar bar is attached to the lower control arm on the other side.

A wire feed mig welder makes the best job of it. The shaped bars are for welding along the top edges of the wishbone, reshape if not following the edges properly, weld on and reassemble front end. The two radius arm strengtheners are to be fitted.

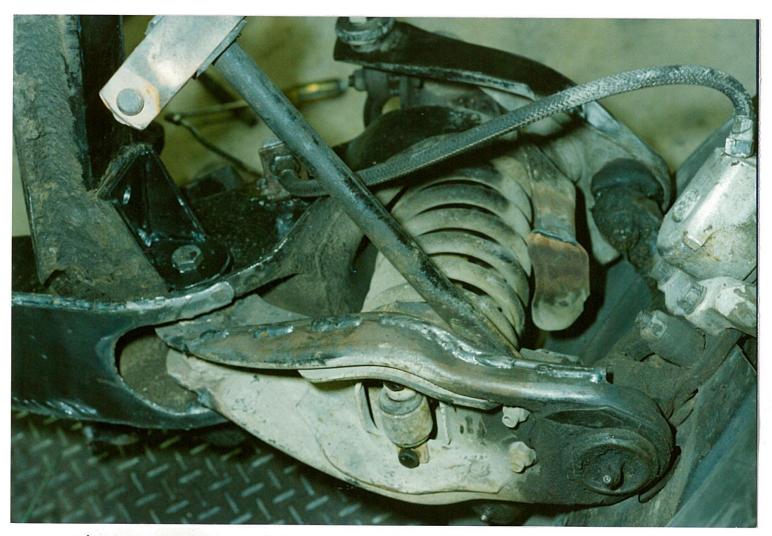
View of other side of suspension control arm where a similar bar is welded on.
This also shows the reinforcement bracket installed between the front crossmember and the torque control arm.

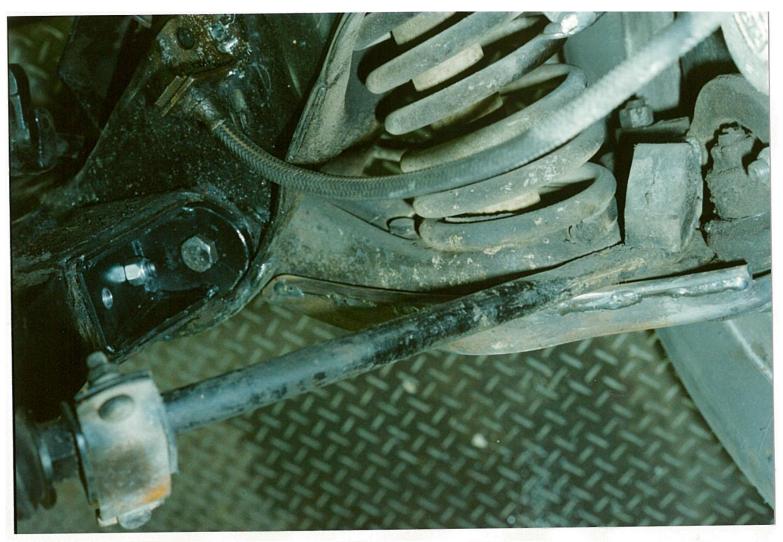
Alternate view of reinforcement bracket

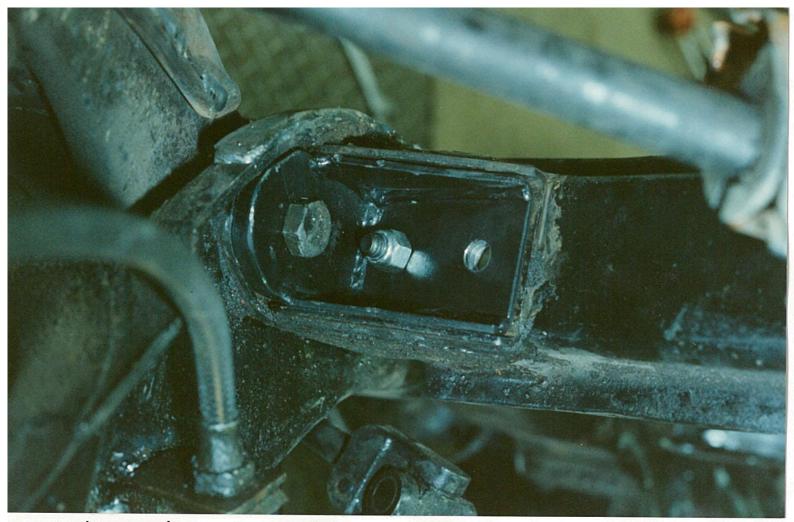
Detailed view of reinforcement bracket, showing the main suspension bolt installed as well as the first side bolt which fits through an existing hole.

A third attachment hole must be drilled to fit the additional bolt required in the longitudinal section.
